EVALUATION OF
CRACKED BRIDGE DECKS TREATED
WITH VARIOUS
HIGH MOLECULAR WEIGHT
METHACRYLATE RESINS
FOR THE
MONTANA DEPARTMENT OF TRANSPORTATION
WJE NO. 981825
July 27, 2000

EVALUATION OF
CRACKED BRIDGE DECKS TREATED
WITH VARIOUS
HIGH MOLECULAR WEIGHT
METHACRYLATE RESINS
FOR THE
MONTANA DEPARTMENT OF TRANSPORTATION
WJE NO. 981825

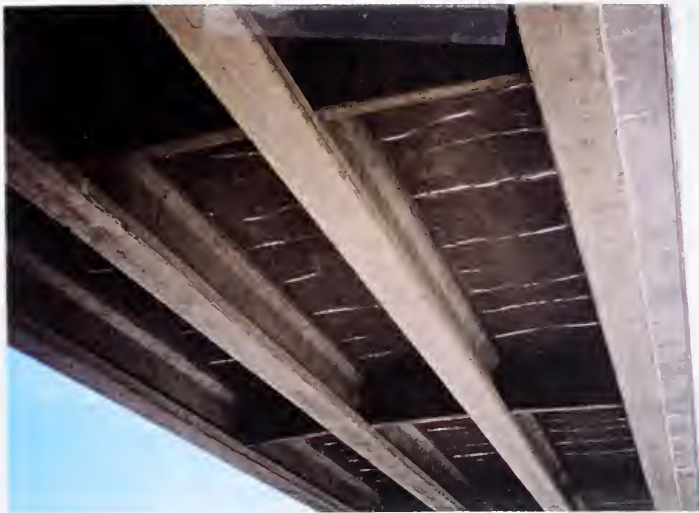
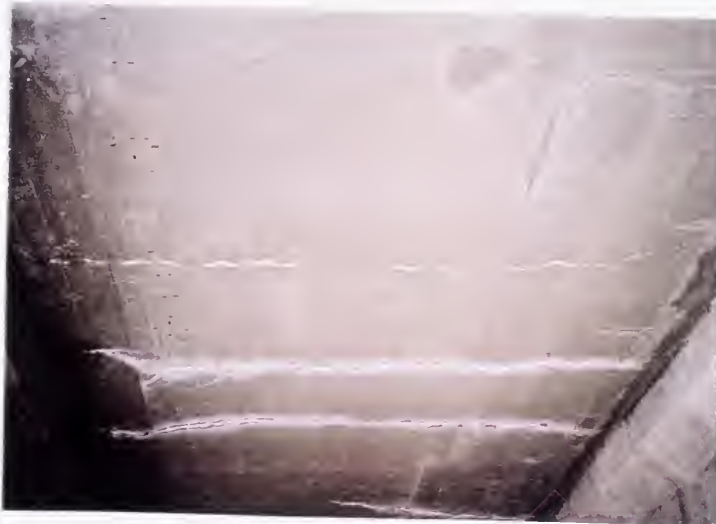
Figure 1 – Typical transverse deck cracking, underside (Br. No. 15)

Bridge 15	I-90	Rock Creek Overpass	MP 126.039	Applied 1992	Transpo Sealate T-70MX-30I
pcc I beams 4 span 2 short 2 long spans 2 span continuous deck					
Underside	Lots of transverse cracks with lots of efflorescence. Doesn't look like it is sealed. Sprinkled some water on Span 1 to look for leakage. No leakage after 15 min.				
Top deck	Transverse cracking worse in Span 1 near abutments. No map cracking

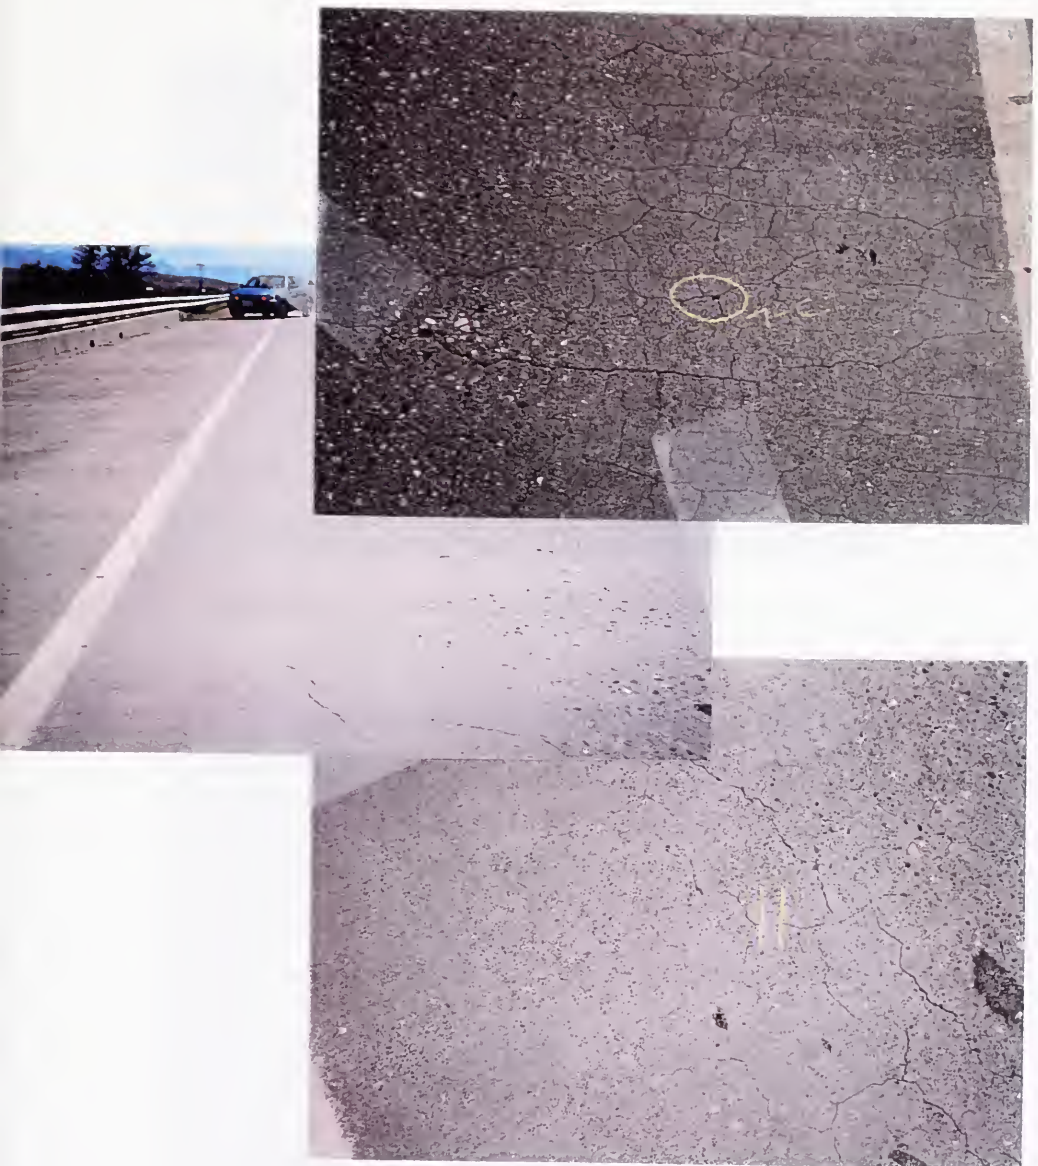
Figure 2 – Longitudinal and map cracking on Bridge Nos. 7 (top), 10 (middle), and 11 (bottom), Three Forks I-90 WB

Bridge 7	I-90-EB	County Rd. Sep.	MP 280.361	Applied 1993	Sika Pronto 19
Precast pcc girders –single span - continuous deck - 5 girders -					
Underside	Some pattern-random cracks. No efflorescence or leaking.				
Top deck	Extensive map cracking in travel lane with predominant transverse cracking. Deck has many pcc patches placed prior to HMWM treatment.

Bridge 10	I-90-WB	Drainage Ditch	MP 280.1	Applied 1993	Sika Pronto 19
Precast pcc girders – 2 span					
Underside	Same as eastbound structure – Bridge 8.				
Top deck	Some pcc patches in travel way. Medium-heavy map cracking in right wheel path. Cracking tends to be more longitudinal than other bridges. Shoulder has light map cracking.

Bridge 11	I-90-WB	Darlington Ditch	MP 279.534	Applied 1993	Sika Pronto 19
Precast I beams – 3 span – simple supports					
Top deck	Many pcc patches. Most patches cracked. Map cracking in right wheelpath.

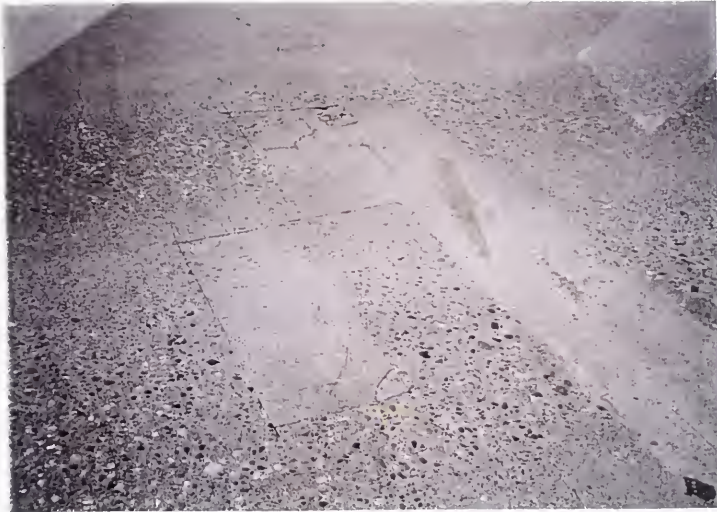
Figure 3 – Deteriorated pcc patches on Bridge 9, Three Forks I-90 WB,
Core location 9-A shown

Bridge 9	I-90-WB	County Rd. Sep.	MP 280.361	Applied 1993	Sika Pronto 19
Precast pcc girders – single span					
Underside	No leaking cracks or efflorescence.				
Top deck	Core 9A in patch showed patches only to top of top mat steel. Patch delaminated at bond line.

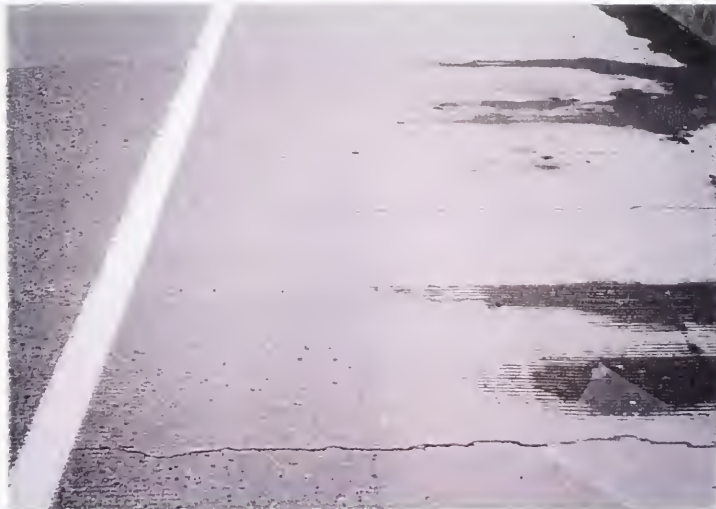
Figure 4 – Transverse deck cracks highlighted after rain on
Bridge No. 18, St. Regis I-90 WB, Core Location 18A

Bridge 18	I-90-WB	St. Regis River Bridges	MP 23.063	Applied 1991	Transpo T 70 - X
3-span steel girder, continuous deck					
Underside	Transverse cracks with efflorescence. Worse away from the abutments. No active leakage after rain (but difficult to see). Cracks grouped in areas. Abutment and center span areas have no cracking.				
Deck	Transverse cracking appears worse on shoulders of the two end spans. Twelve-foot shoulder, faint longitudinal cracking in right WP to EP stripe. Less transverse cracking over the piers and near the abutments. Good candidate bridge for transverse deck cracking due to large steel girders (flexible). The deck has about 47 obvious transverse cracks over its approximately 400-ft length. Flexible deck with vertical movement under live load. (same as 17).

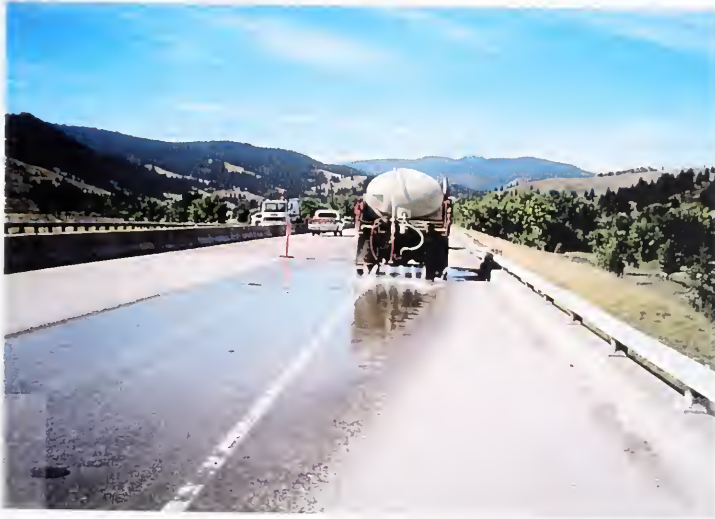
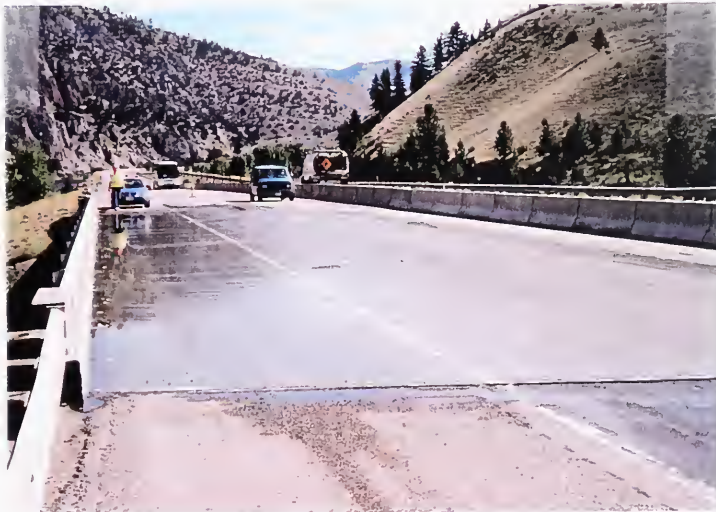
Bridge 13 (I-90 WB, MilePost 143.651) was flooded with water as shown in Figure 5. The through-deck cracks were monitored and no active leakage was noted. Also, new deck cracks in the top surface were not identified as the deck surface dried.

Figure 5 – Wetting surface of Bridge 13 (I-90 WB, Mile Post 143.651)
